Field Service Bulletins

ADC Quality System 2.0.xx

Field Service Bulletin No. 1

New software version

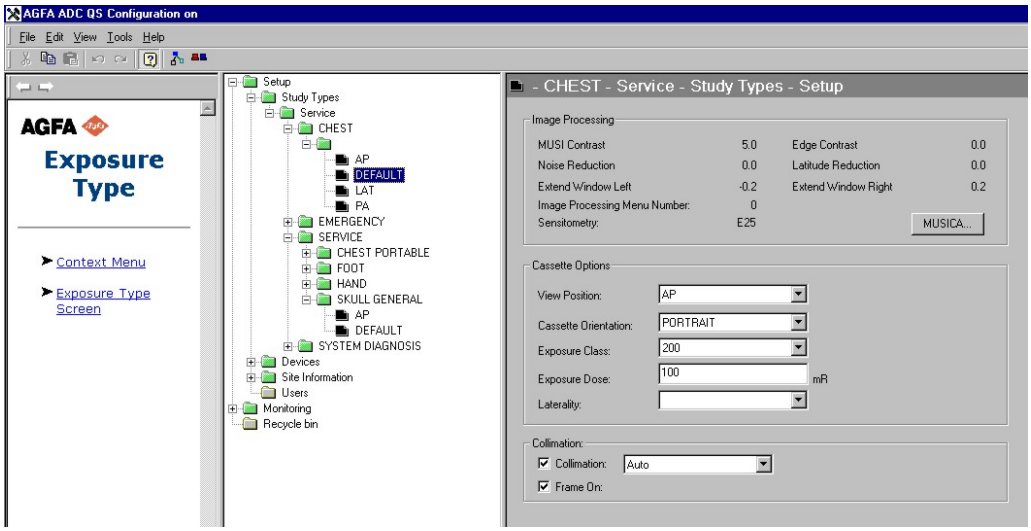
Problem: If the SUB EXAM name contains the view position, e.g. AP; PA, LAT, this patient position is not derived correctly.

As a result, the system does not use the Image Processing parameters as configured in the cpf-file, but a default setting that puts Edge Contrast, Latitude Reduction and Noise Reduction to 0 and MUSI Contrast to 5.

Solution: Installation of ADC QS 2.0.09 resolves the problem.
